AMMRC-TR-82-43

FRACTURE ANALYSIS OF REACTION-BONDED SILICON NITRIDE TURBINE SHROUDS

JUNE 1982

**ARMY MATERIALS AND MECHANICS RESEARCH CENTER
Watertown, Massachusetts 02172**

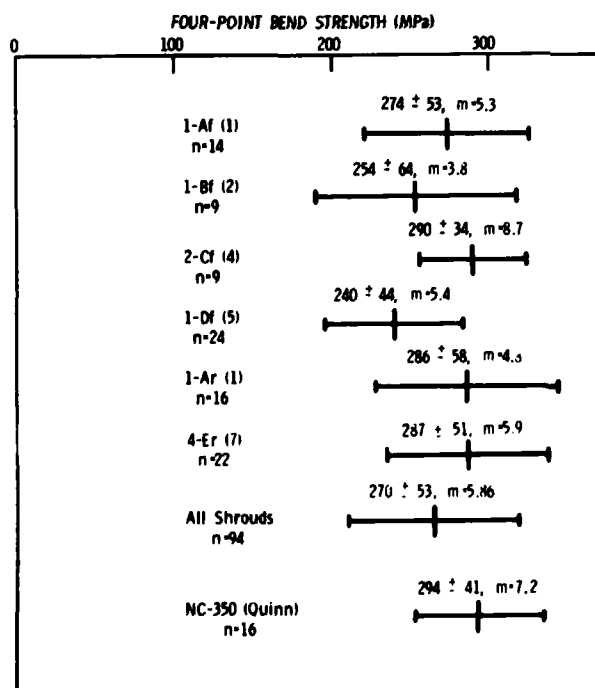
Although the shrouds were tested in an oxidizing environment for up to 50 hours at temperatures (900°C) at which internal oxidation may have degraded properties⁸ none of the failures appear to have been corrosion-related. In support of this conclusion are the data summarized in Figure 34 which shows the mean strength values for each set of bend specimens (except for the five tested with as-received surfaces) as well as baseline data

Figure 34. Results of bend tests conducted on specimens machined from RBSN shrouds. The error bars indicate standard deviations.

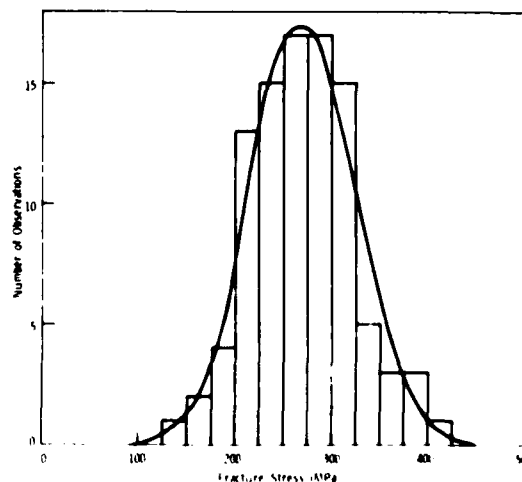
Figures 35 and 36 show the bend test data plotted according to a normal distribution.¹⁰ It is evident that they fit such a distribution well, justifying the use of statistical comparative tests that assume such a distribution. It is also noteworthy that there is no apparent "cutoff" at the lower stress levels, as might be expected if there were a minimum "proof" strength.

Figure 35. Histogram of bend bar fracture data with normal distribution curve overlay.

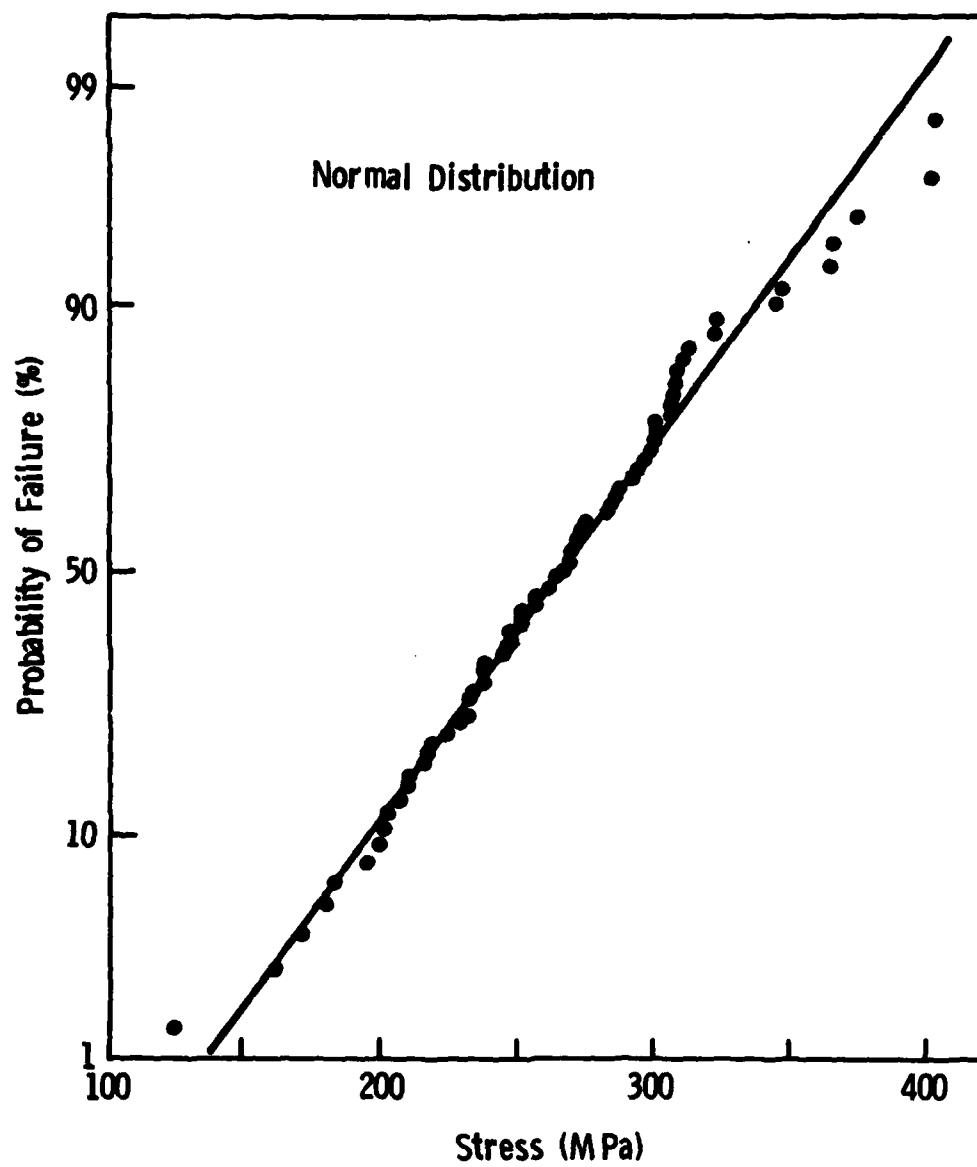
Figure 36. Data from all bend tests plotted according to a normal distribution function.

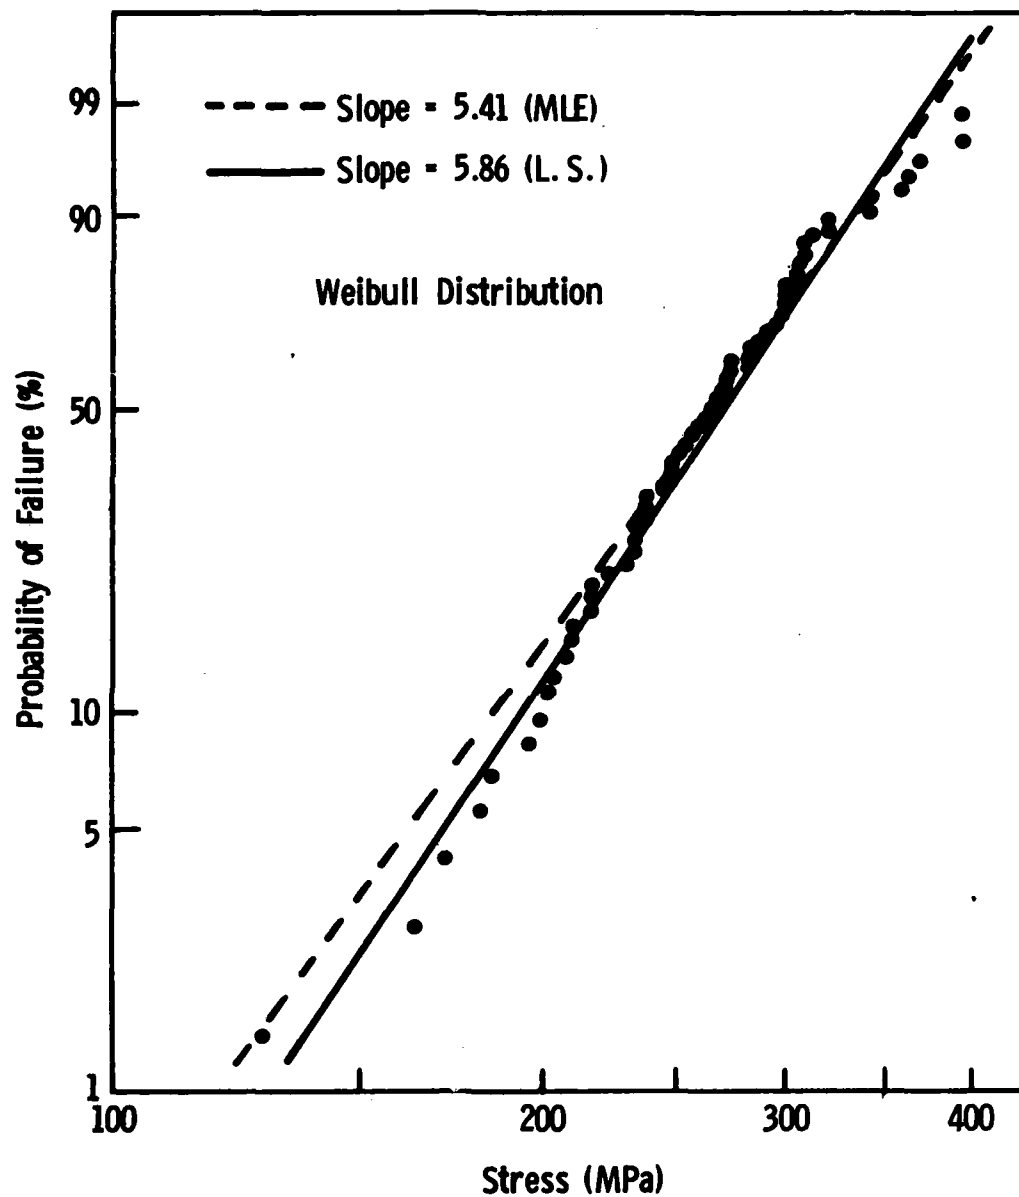
Figure 37 shows the data plotted according to the Weibull distribution which one would expect to obtain from theoretical considerations.⁹ Again the fit is satisfactory. Also given in Figure 37 are Weibull modulus values obtained by both least squares (LS)¹⁰ and maximum likelihood estimator (MLE)¹¹ techniques. The advantage of the MLE technique is that it gives error bounds while the LS technique does not.

Table 3 summarizes the calculated results of statistical parameters for the data plotted in Figures 35 through 37. Note that the modulus value of 5.6 obtained by the LS technique is well within the MLE bounds of m = 4.4 to 6.0 at the 90% confidence level.

Figure 37. Data from all bend tests plotted according to the Weibull distribution function.

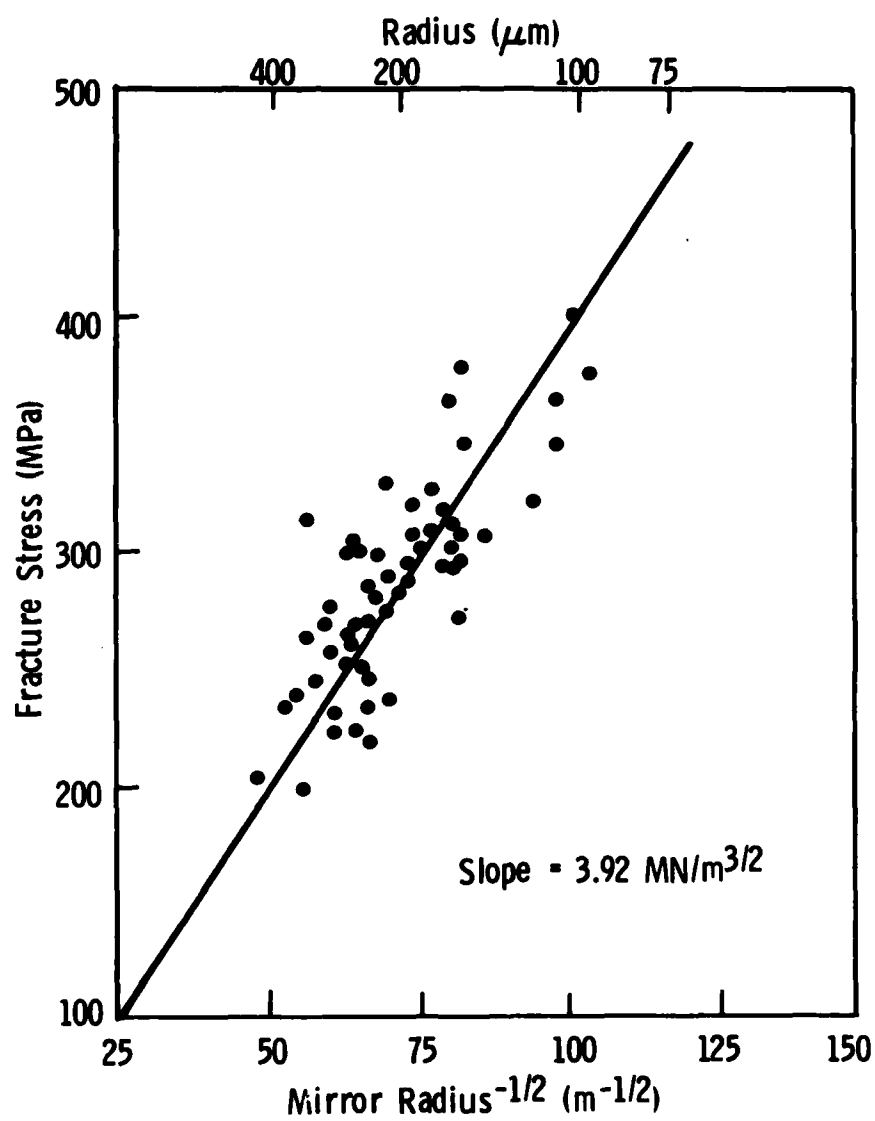
Figure 38 is a plot of fracture stress versus mirror radius. A least squares analysis of the data yielded a value of $A = 3.92 \text{ MN/m}^{3/2}$. This value is in reasonable agreement with the value of $4.2 \text{ MN/m}^{3/2}$ reported by Kirchner et al.¹³ for a different grade of RBSN, and also with that of $3.19 \text{ MN/m}^{3/2}$ reported by Larsen and Walther¹⁴ for the same type of material (NC-350) investigated in this study.

Figure 38. Fracture stress versus fracture mirror radius after Equation 1.
All data are from bend specimens.

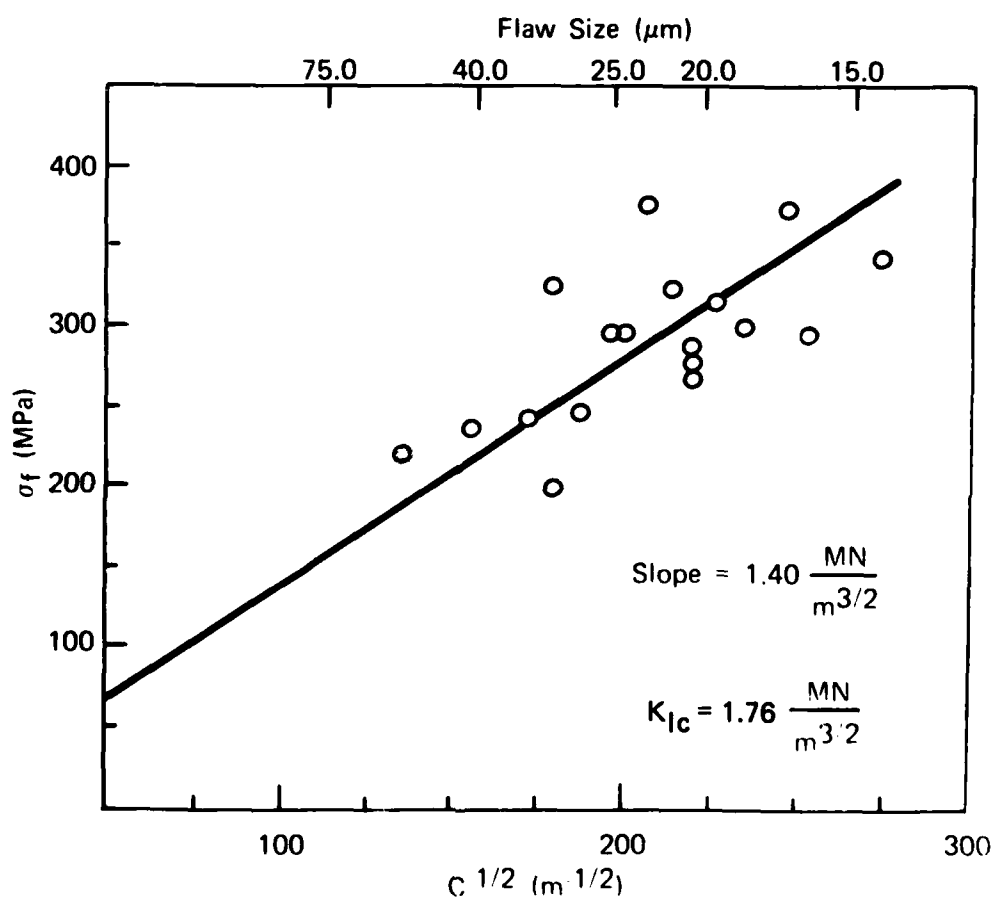
Figure 39. Fracture stress versus flaw size after Equation 2. Insert shows typical flaws.
